Metropolitan Fire Service

REPORT:

FIREFIGHTER INJURIES
EAST AVENUE,
BEVERLEY

9th April 2013

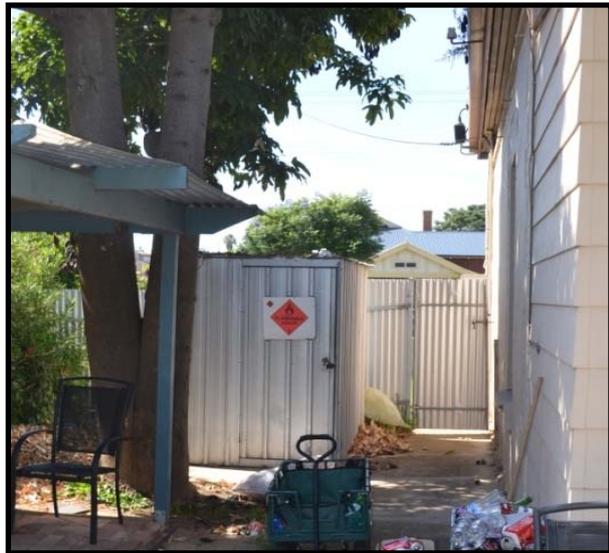
Figure 1 - Shed with Hazmat signage

I then went around the back as there was a side driveway off of Spring Street. I noticed there was a new looking 4wd in the drive way. I thought to myself that the handicapped man wouldn't be driving it and there should be someone here looking after him. So I assumed that there was someone inside that owned the 4wd. I went right around the back of the house and down the other side. I didn't see any flame or smoke coming out the windows. However I noticed two tool sheds with hazmat signs on them (Figure 1).

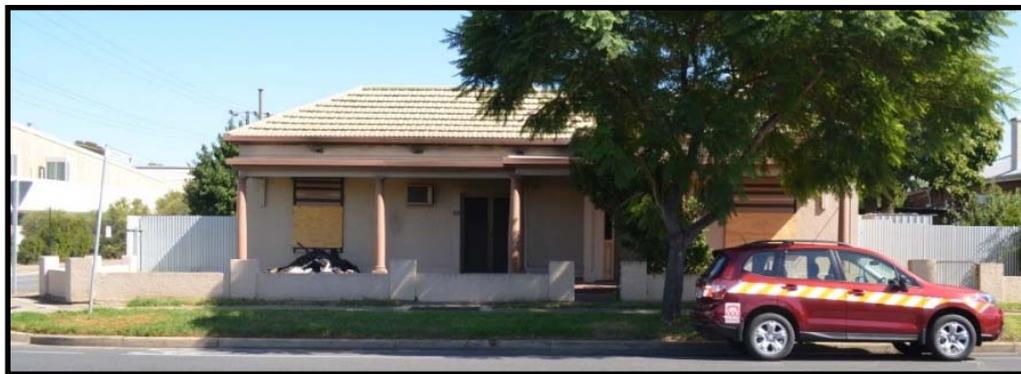
Figure 2 – 50 East Avenue Beverley

The premises located on the north-western corner of East Avenue and Spring Street was originally two, single storey semi-detached residential Units sharing a common dividing wall (A plan of the premises is provided in Appendix 3). It was constructed of brick external and internal walls, with a timber framed iron roof that had been capped with artificial / aluminium tiles. Interior floors were timber with a combination of linoleum and carpet coverings. The three metre high ceilings were lath and plaster.

The windows to the property were timber sashed and fitted with security shutters to the external side. Two Roller shutters, in the 'down' position were located on the east side with one more on the north-western corner of the building. Aluminium security mesh was fitted to the remaining windows. A ducted air conditioning system was fitted with air registers throughout.

From the exterior, the property can be seen to have two front and two rear access doors, however on the inside, a number of internal walls have been removed or breeched to provide access between the Units creating a common detached five bedroom residence. Two garden sheds with HAZCHEM placards were located in the yard on the northern side.

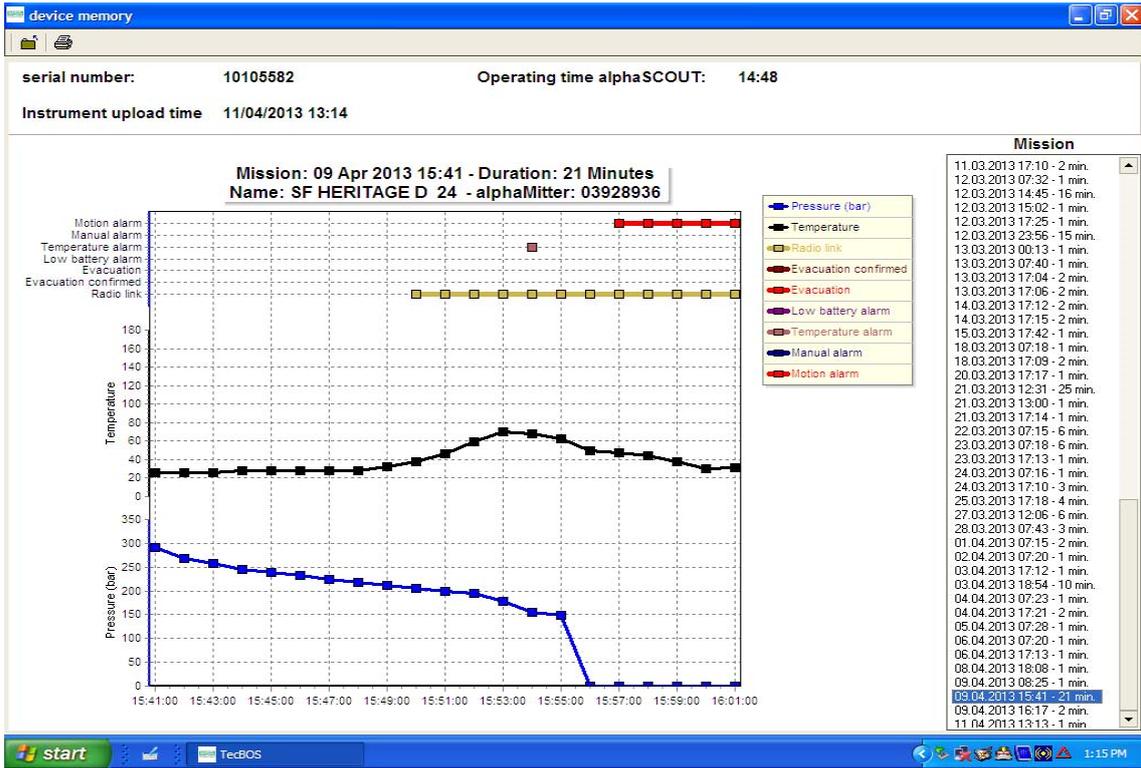
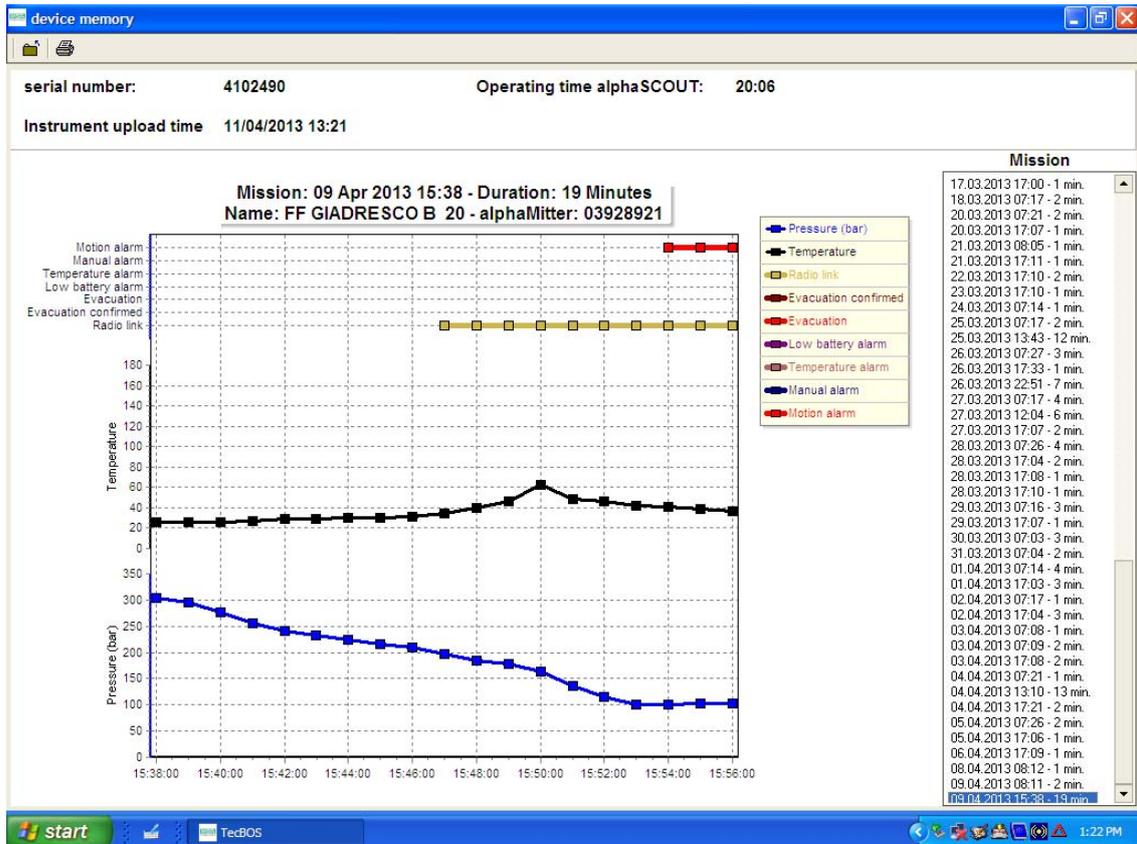
Figure 3 - Data from S/F Heritage's & F/F Giadresco's BA Sets

The BA sets worn by S/F Heritage and F/F Giadresco have the capability to record ambient temperatures during operational periods. Data download from the alphaSCOUT worn by S/F Heritage indicated that he experienced temperatures in the 70°- 75° C range. A high temperature alarm (set to operate at 71° Celsius) activated on S/F Heritage's set.

The data downloaded from both firefighters' airsets is provided in Figure 3.

The temperature sensor on S/F Heritage’s air set recorded temperatures in the 70° C range. As previously noted, first degree burns can occur at skin temperatures of approximately 48° C Second Degree burns at approximately 55° C and instantaneous skin destruction at approximately 72° C.

- 1. Current practice and procedures in regards to the appropriate donning of PPE are reinforced at all times including training, exercises and incidents*
- 2. The MFS reviews current training information to include details of the function and operation of the high temperature alarm in the alphaSCOUT.*
- 3. Recommend that the high temperature alarm is covered in future BA courses.*
- 4. The MFS investigates the functionality of the alphaSCOUT TM high temperature alarm.*
- 5. The alarm should have a "latched" feature that requires acknowledgment by the user.*
- 6. The MFS investigates the possibility of the high temperature alarm being transmitted via the alpha Personal Network to the alphaTABLET.*
- 7. The MFS develops a procedure in the event of the operation of an alphaSCOUT high temperature alarm activation*

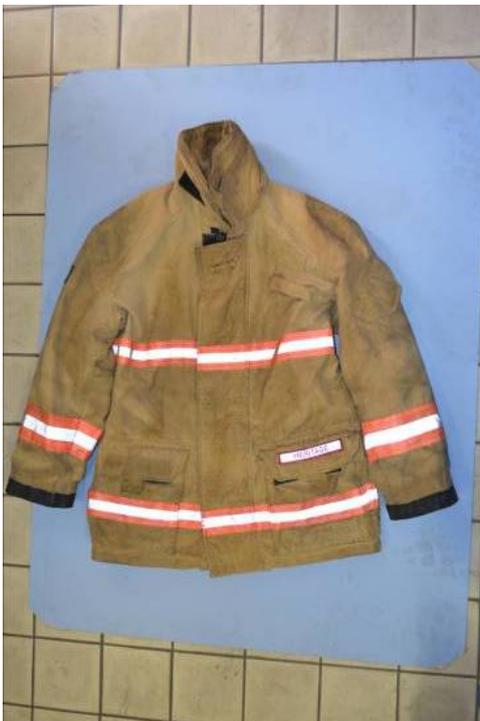
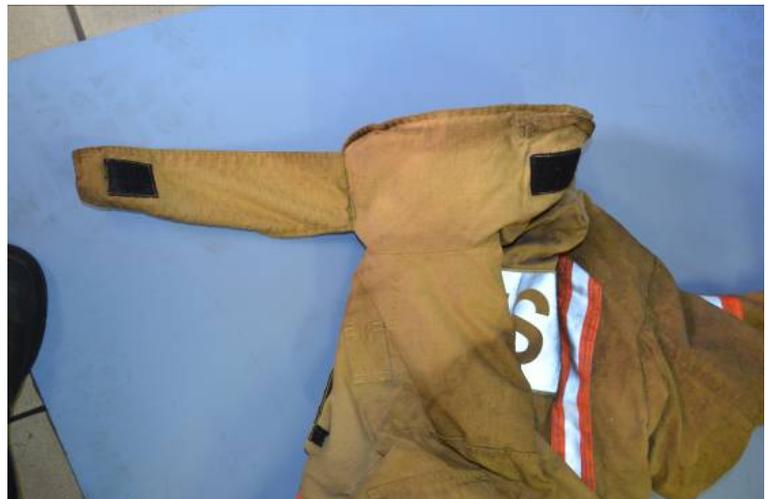
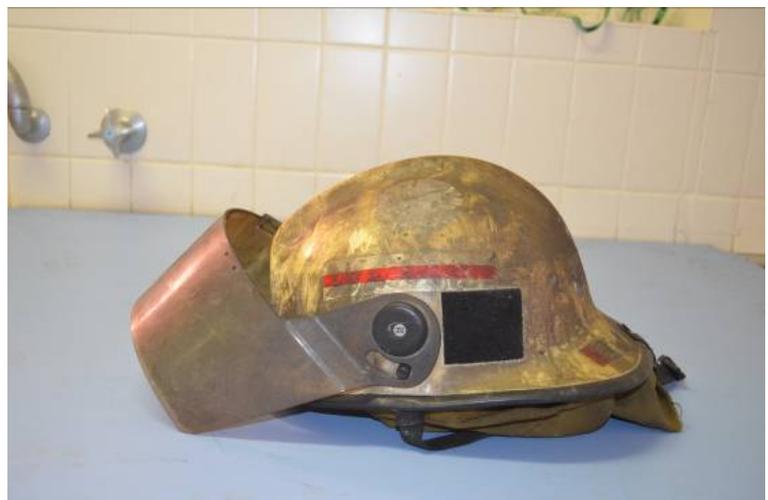
Figure 4

As the branch operator, S/F Heritage would have been sprayed with the largest amount of reflected water and it appears that he did not have his collar in the upright position with the neck flap secured – allowing a greater opportunity for water to get inside his PPE. By backing up S/F Heritage on the hoseline, F/F Giadresco may have also been largely shielded from the reflected water spray by S/F Heritage. Giadresco did have his collar extended with the collar flap secured. He received burns around the throat area, believed to be caused by the water that had sprayed on to his facemask running off and soaking into his flash hood.

- The PPE was heavily soiled by soot,
- There was no apparent flame impingement or heat damage to either F/F's PPE,
- The inspection of S/F Heritage turnout coat indicated the neck flap had not been in use,
- The BA sets continued to function in this situation and show no signs of flame or heat damage,
- There was no observable PPE failure.

**PPE Worn by S/F Heritage at
the Beverley House Fire
Incident**

1. Lion Apparel level 2 Structural fire fighting jacket
 - Jacket has moderate contamination
 - Pronounced demarcation of contaminated area to clean area outlining SCBA wear

- Pronounced demarcation of contaminated area to clean area appears to denote that neck flap was not in use
 - No apparent flame or heat damage
2. Jacket liner

10. PACIFIC structural fire fighting helmet, torch and neck flap
 - Helmet and torch grossly contaminated
 - Face shield grossly contaminated, missing left hand side tag
 - Neck flap displays moderate wear and tear consistent with age and use, multiple holes and fraying seams
 - Chin strap intact
 - Bump cap intact
 - No distortion or melting of face shield
 - Velcro name tag patch may display dome degree of distortion
 - No apparent sign of flame or heat impingement
11. MSA SCBA and cylinder, set # 47
 - Moderately contaminated
 - Face mask relatively clean
 - No apparent flame or heat damage

The need to have appropriate levels of PPE worn correctly are paramount with particular attention to be paid to details such as thumb loops, collar flap, helmet flap and flash hood – BA mask interface.
